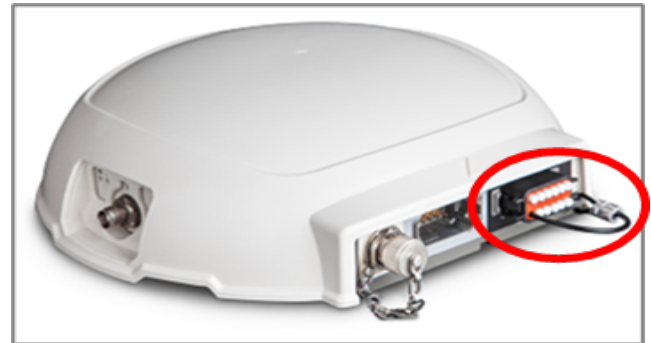
1

Connect the RV50 to the AGI 4 with the adapter cable and black connector on the back of the receiver

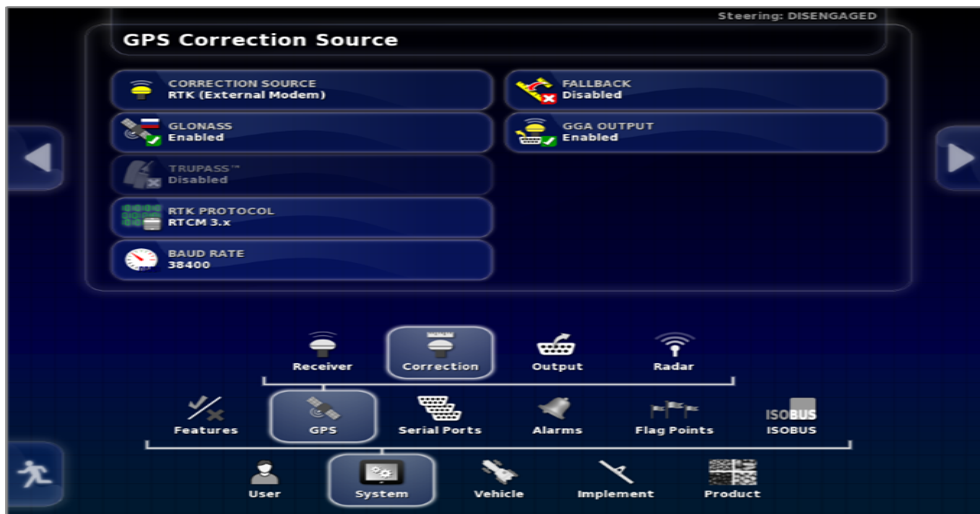
2

Navigate to the Wrench icon, then System, then GPS, then Correction; configure the GPS correction source page to match the screenshot:

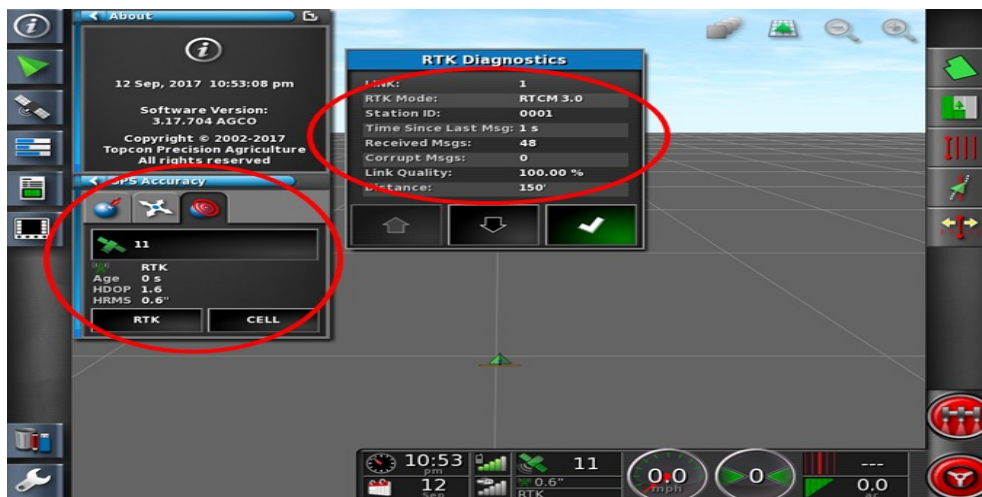
3

Return to the Run screen to confirm RTK fix as in the screenshot:
